Intel[®] StrongARM[®] SA-1100 Evaluation Platform

Specification Update

December 1999

Order Number: [278246-005](#)

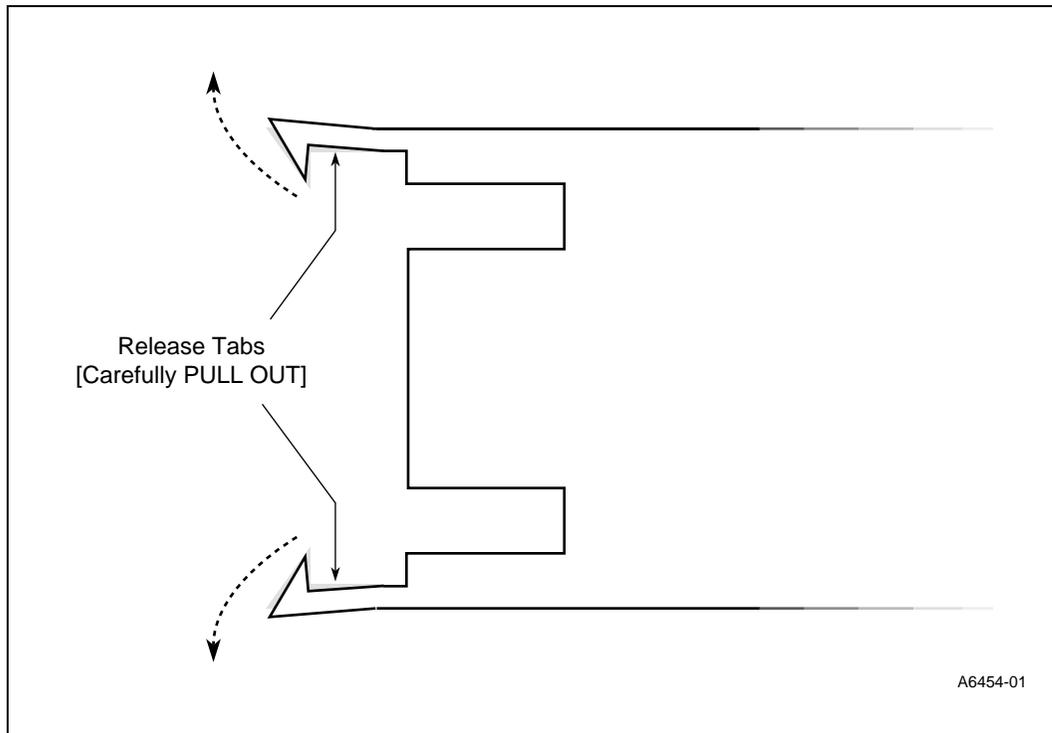
Figure 1. Ejector Mechanism

1. PCMCIA Ejector Mechanism Problem

Problem: The PCMCIA ejector mechanism can short to a via on the board of the SA-1100 evaluation platform when a PCMCIA card is installed.

Implication: The SA-1100 evaluation platform will not work properly and could become damaged if a PCMCIA card is installed.

5. Place a small flat tipped screwdriver under the black locking tabs, which are located just above the “41” of “TP 41.” Gently pull the tabs out by twisting the screw driver (see [Figure 1](#)) while rocking and pulling the ejector mechanism towards the right-hand edge of the board. Be careful to lift the ejector over C17.
